FERC SP-G2

DRAFT Erosion Site Description and Analysis Summary

STATE OF CALIFORNIA
DEPARTMENT OF WATER RESOURCES
Oroville Facilities Relicensing
FERC Project No. 2100

SP-G2 Task 5B

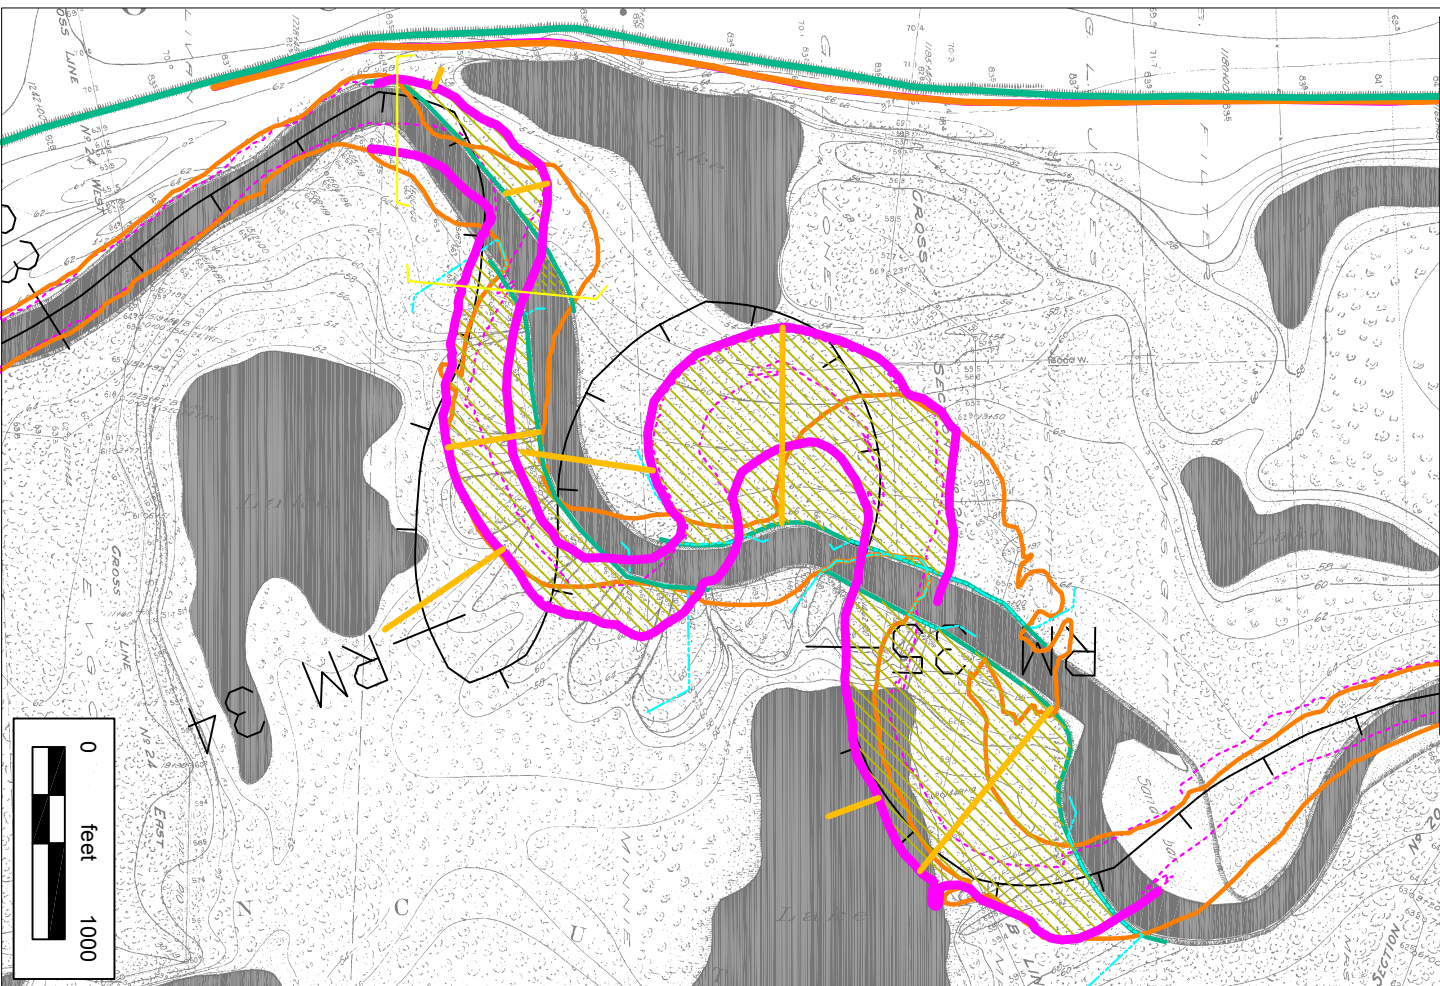
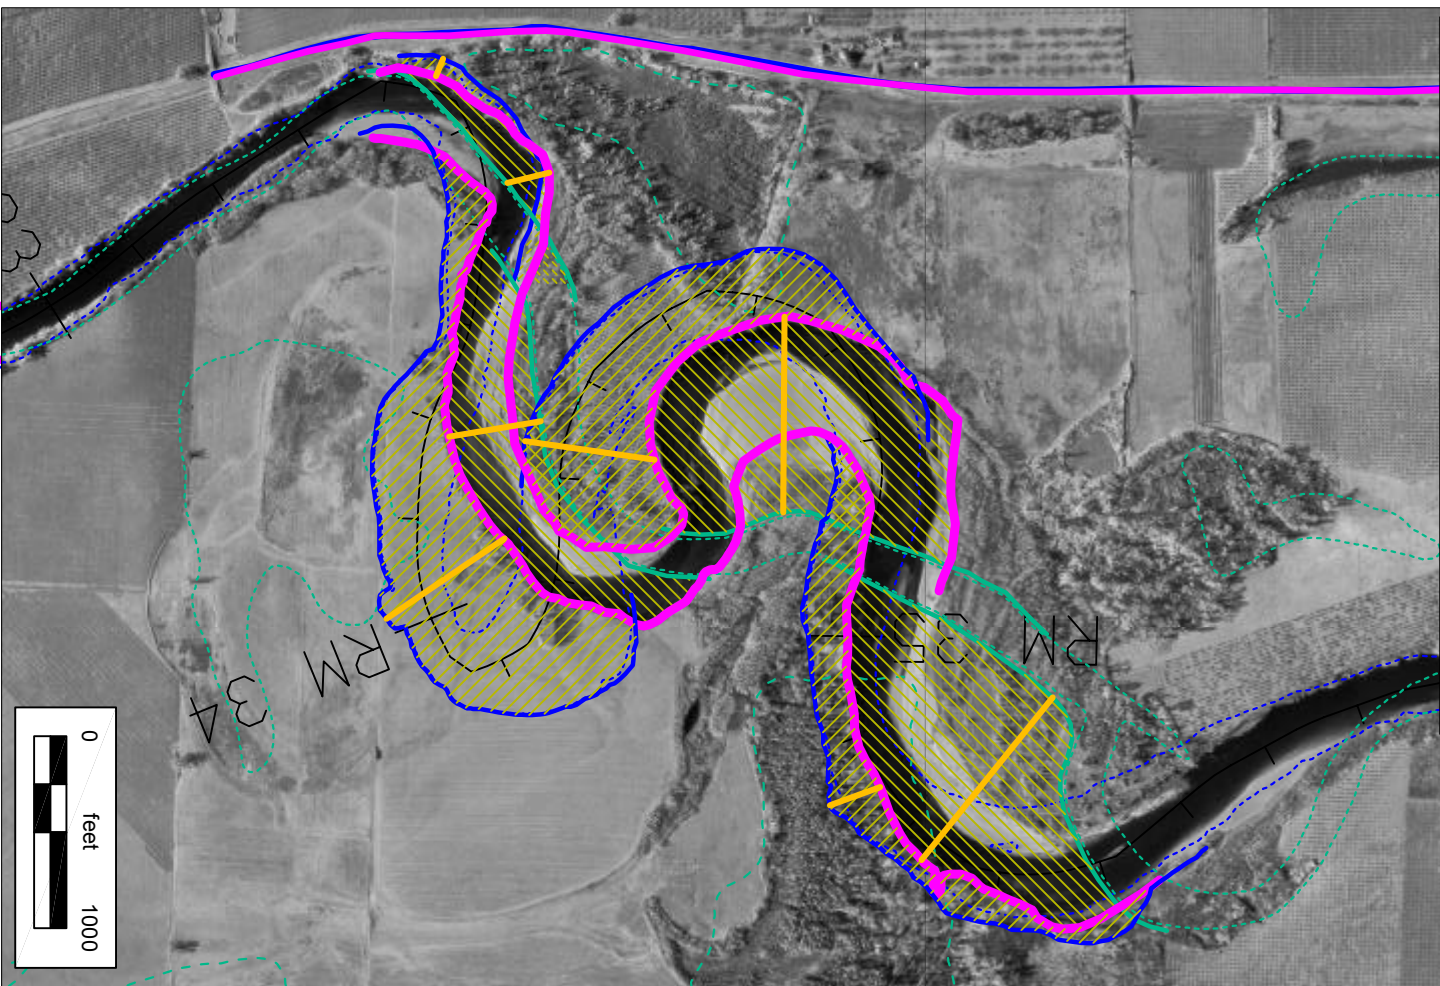
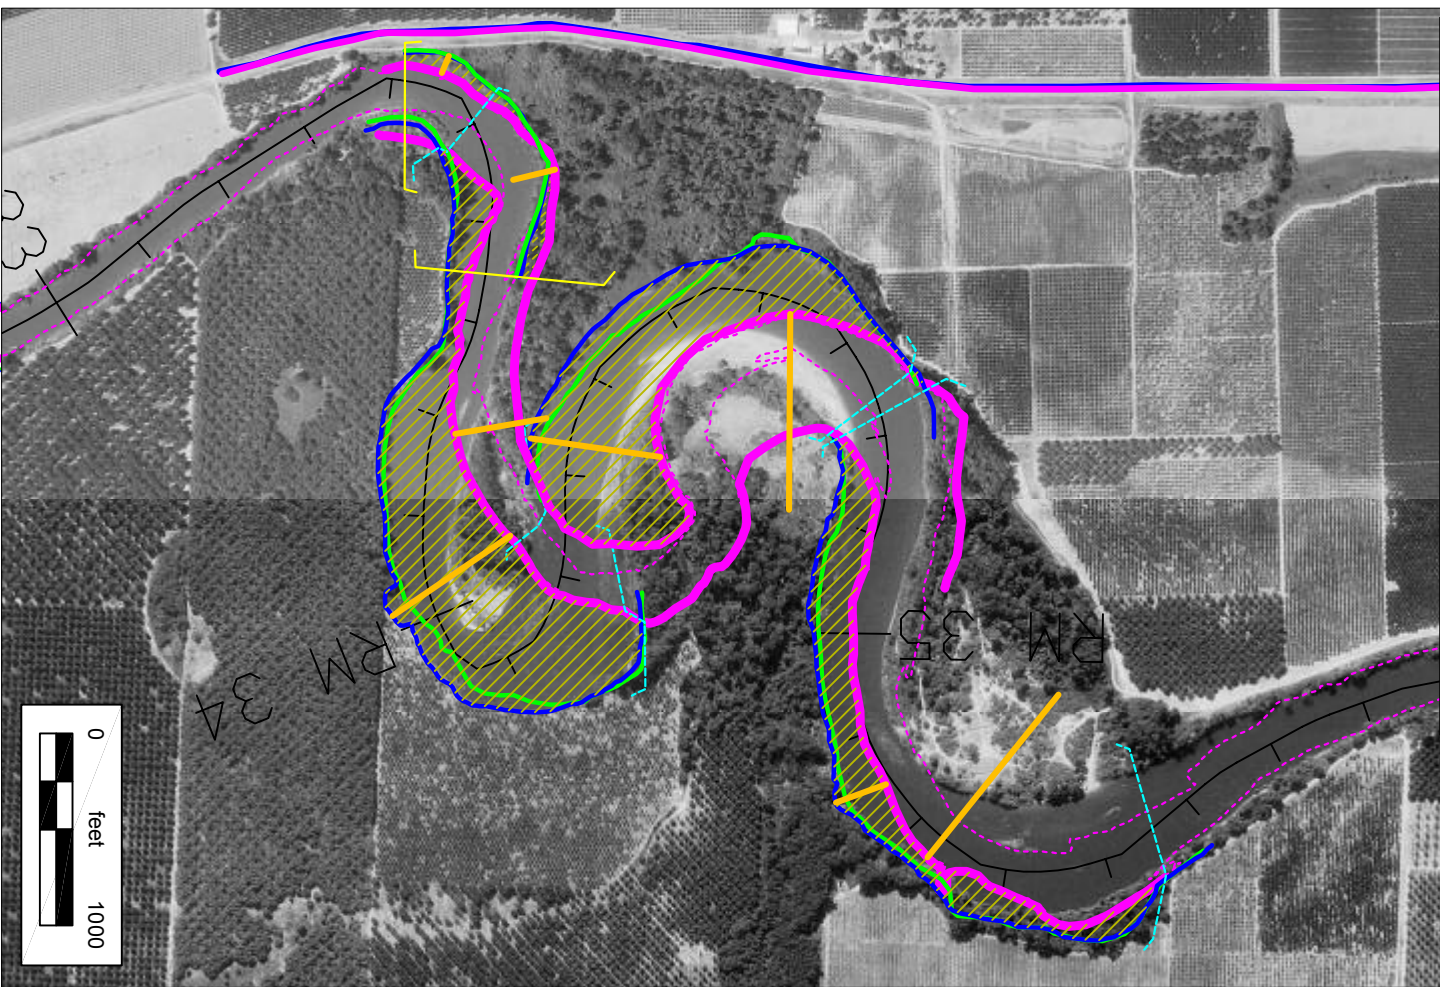
Rivermiles: 33.5 right bank

Description: Pre-dam analysis years: 1909-1956 is characterized predominantly by erosion, with only minor aggradation; 1956-1967 is characterized by both erosion (occurring at the downstream portion of the site) and aggradation (occurring at the upstream portion of the site). Aggradation accounts for about 60 percent of the total change in channel area during the 1956-1967 time period. Maximum pre-dam erosion occurs within the upstream half of the site.

Post-dam analysis years: 1967-1986 is characterized by both erosion (occurring at the downriver portion of the site) and aggradation (occurring at the upstream portion of the site); aggradation accounts for about 45 percent of the total change in channel area during this time period. 1986-1998 is a period characterized by very little change, with only minor erosion and even less aggradation. Maximum post-dam erosion occurs within the downstream half of the site.

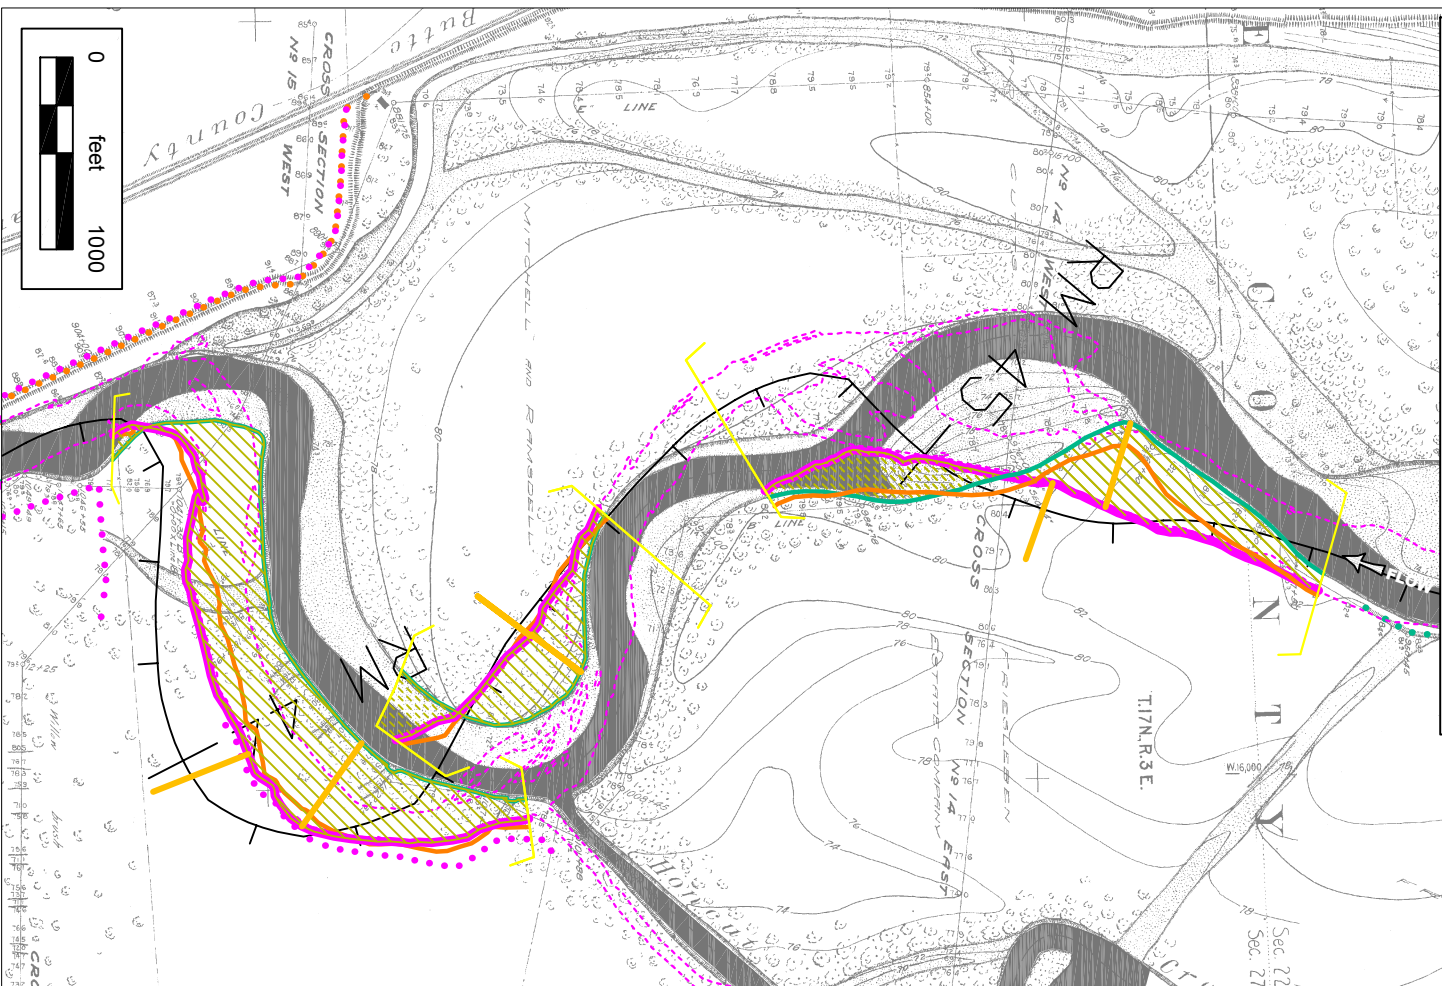
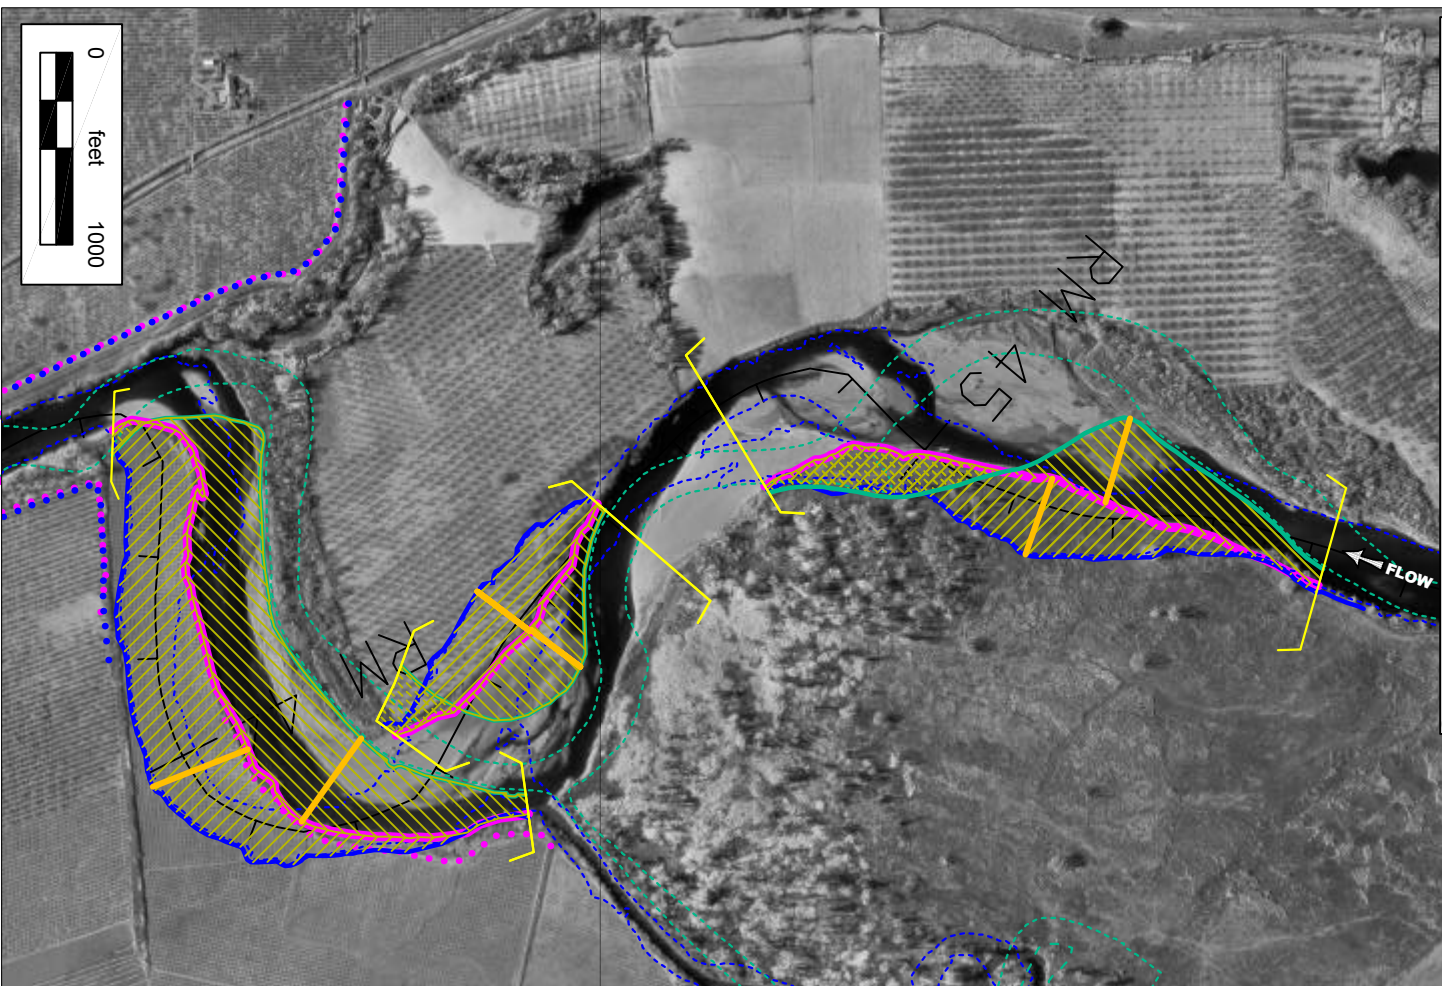
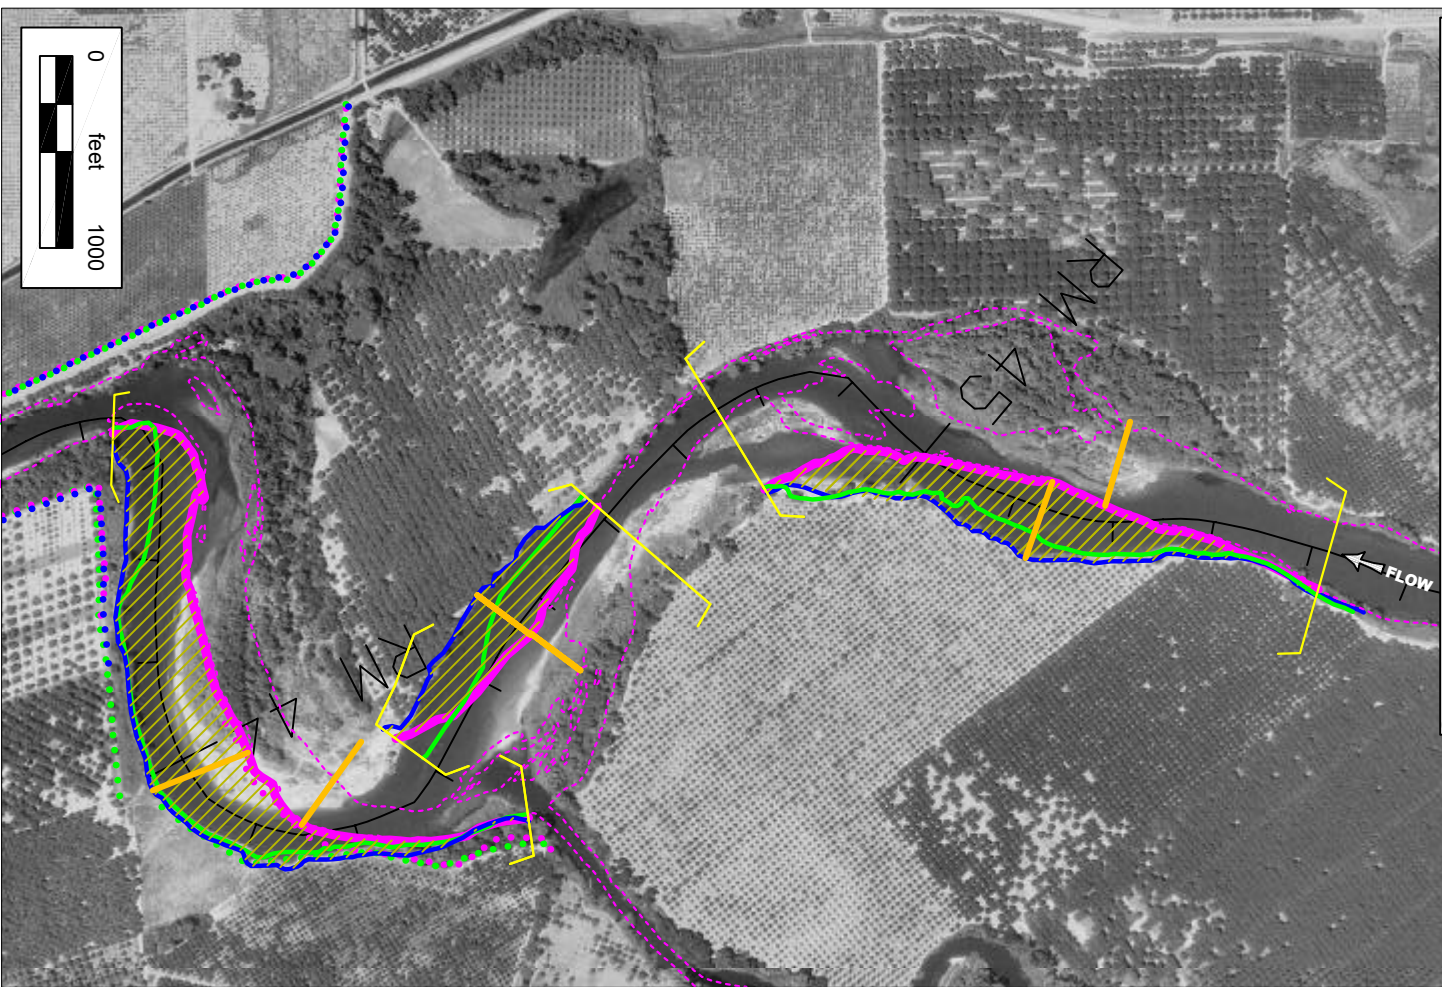
Rivermiles: 44 left bank
44.4 right bank
45 left bank

Description: Pre-dam analysis years: 1909-1967 is characterized predominantly by erosion, which occurs at a non-uniform rate; aggradation accounts for less than 5 percent of the total change in channel area during this time period. Measured maximum erosion occurs within the upstream half of the site.

Post-dam analysis years: 1967-1998 is characterized predominantly by erosion, which occurs at a non-uniform rate; aggradation accounts for less than 1 percent of the total change in channel area during this time period. Measured maximum erosion occurs at about the midpoint of the site.

Description: Pre-dam analysis years: 1909-1967 is characterized predominantly by erosion, which occurs at a non-uniform rate; aggradation accounts for about 26 percent of the total change in channel area during this time period. Measured maximum erosion occurs at the midpoint of the site.

Post-dam analysis years: 1967-1998 is characterized predominantly by erosion, which occurs at a non-uniform rate; aggradation accounts for about 7 percent of the total change in channel area during this time period. Measured maximum erosion occurs at about the midpoint of the site.

Description: Erosion at this site reversed the direction of the meander bend from a left-hand to a right-hand curve. The Debris Commission Survey in 1909 indicates that the erosional bank was on the river-right side; however, subsequent aerial photos indicate a shift in the erosional bank from the river-right to the river-left side. Because of this shift, the large left-hand curve in the river is straightening, and shows some reversal in post-dam construction aerial photos. This reversal has caused the downstream left-hand bend to become more abrupt, and most likely has accelerated the erosion on the downstream right-bank.
